DELaware RIVER BASIN
MILL DAM
COMMONWEALTH OF PENNSYLVANIA
WERNERSVILLE STATE HOSPITAL

NDI NO. PA-00711
DER NO. 6-295
BERKS COUNTY, PENNSYLVANIA

PHASE I INSPECTION REPORT
NATIONAL DAM INSPECTION PROGRAM

PHASE I REPORT
NATIONAL DAM INSPECTION PROGRAM
BRIEF ASSESSMENT OF GENERAL CONDITIONS
AND RECOMMENDATIONS

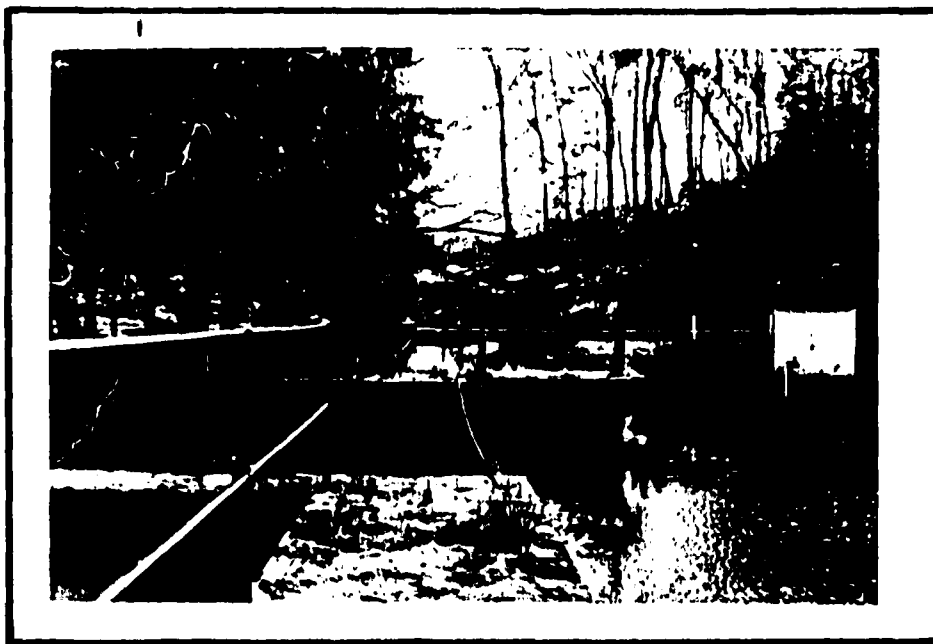
TOP VIEW FROM LEFT END - NO. 2

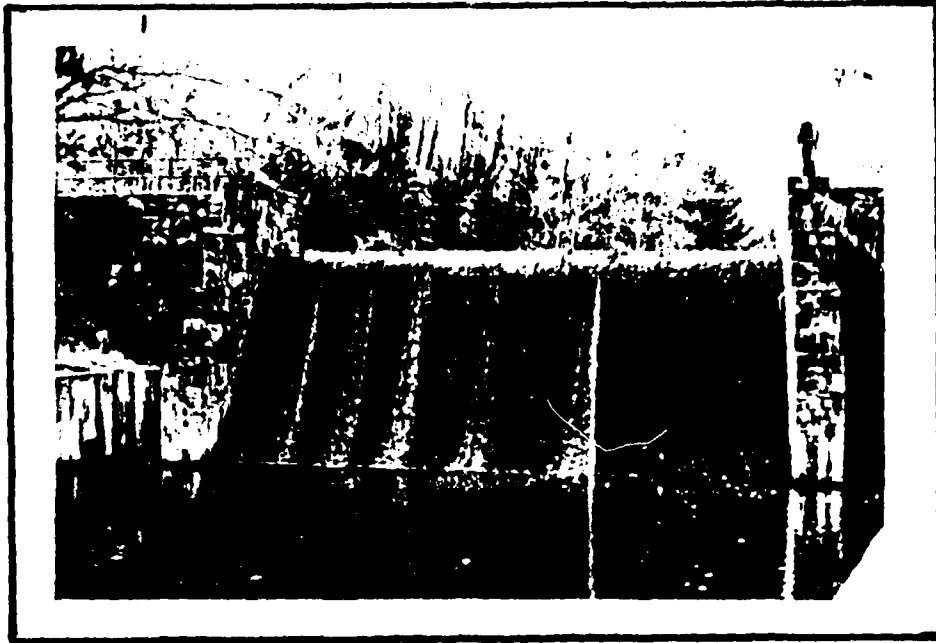
The spillway was in good condition, with only a slight weathering of the surface.

DOWNSTREAM FACE OF SPILLWAY - NO. 4

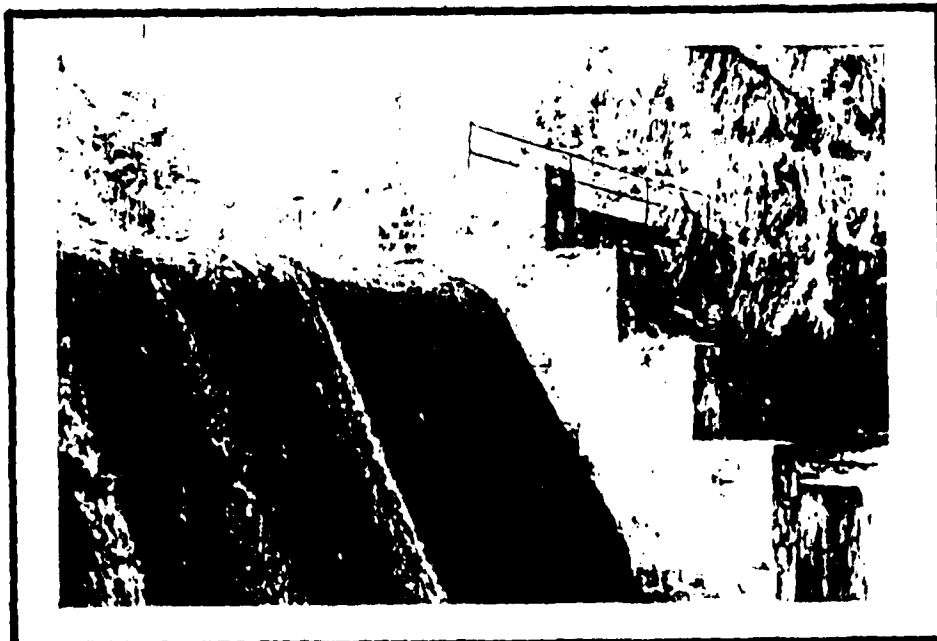
DETAIL OF LEFT SPILLWAY WALL - NO. 5

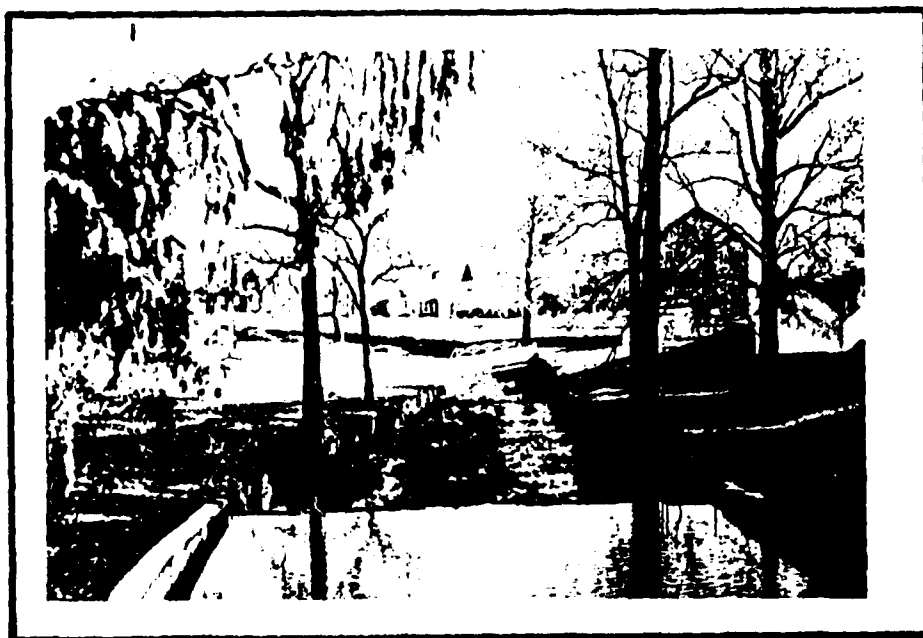
The immediate downstream channel of Mill Dam is a well defined channel with stone walls (Photographs No. 6 & No. 7). A bridge across the stream is located about 380 feet downstream from the dam. The stream flows through a flat area with many of the hospital buildings close to the stream. A potential hazard to loss of life exists downstream if the dam fails. The possible loss of lives would be more than a few. The hazard category for Mill Dam is considered to be "high."

DOWNSTREAM CHANNEL BEYOND STILLING BASIN - NO. 6
NOTE VEHICULAR BRIDGE

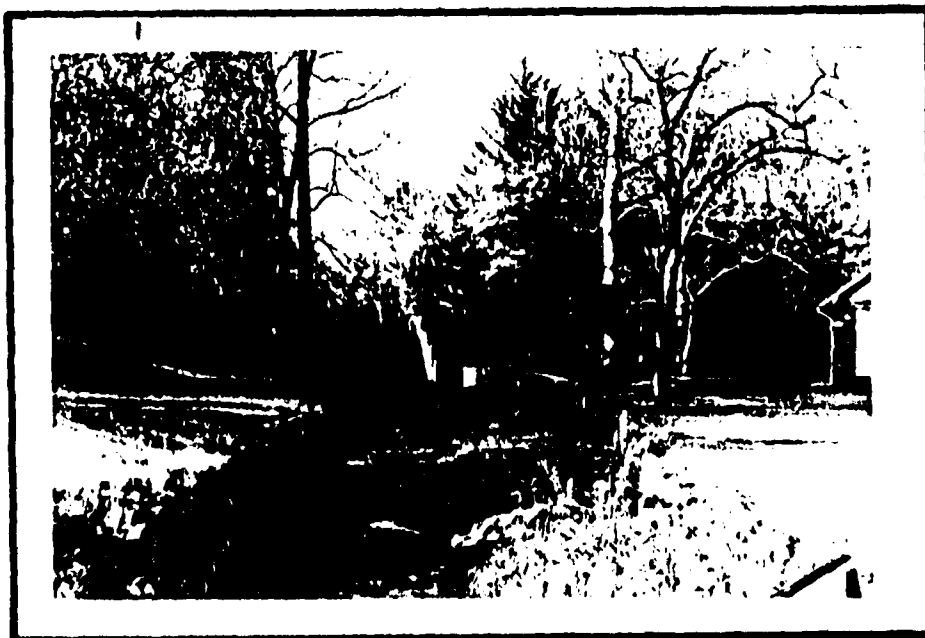
DOWNSTREAM CHANNEL LOOKING UPSTREAM - NO. 7

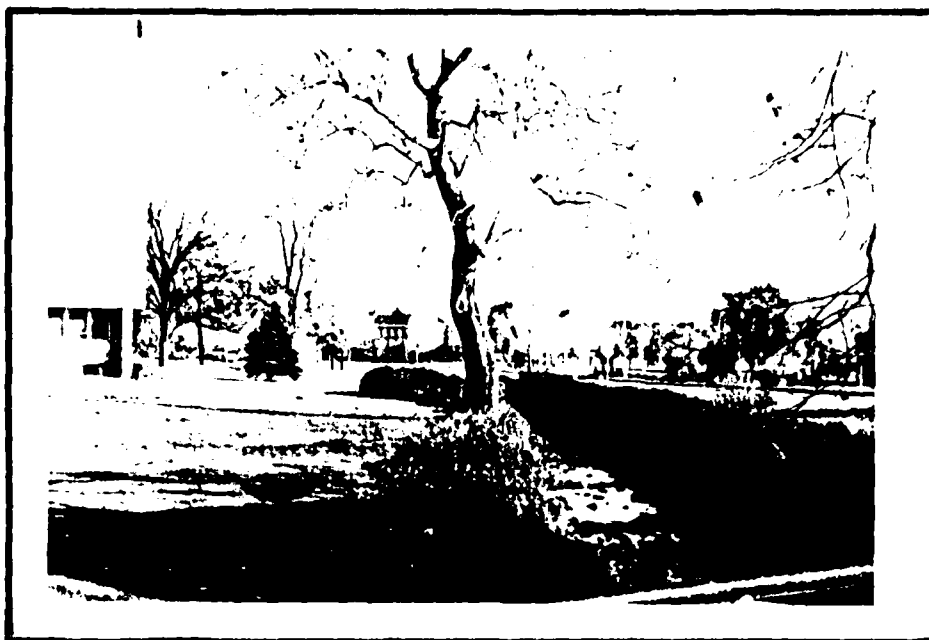
DOWNSTREAM CHANNEL BEYOND BRIDGE - NO. 8
